10 November 2020
417541-99-02-L20-0775,
Revision A

Nill Building Solutions
67 Mariner Drive
Southampton, NY 11968

Subject: Proof and Ultimate Load Testing Performed on Nine Anchoring Brackets

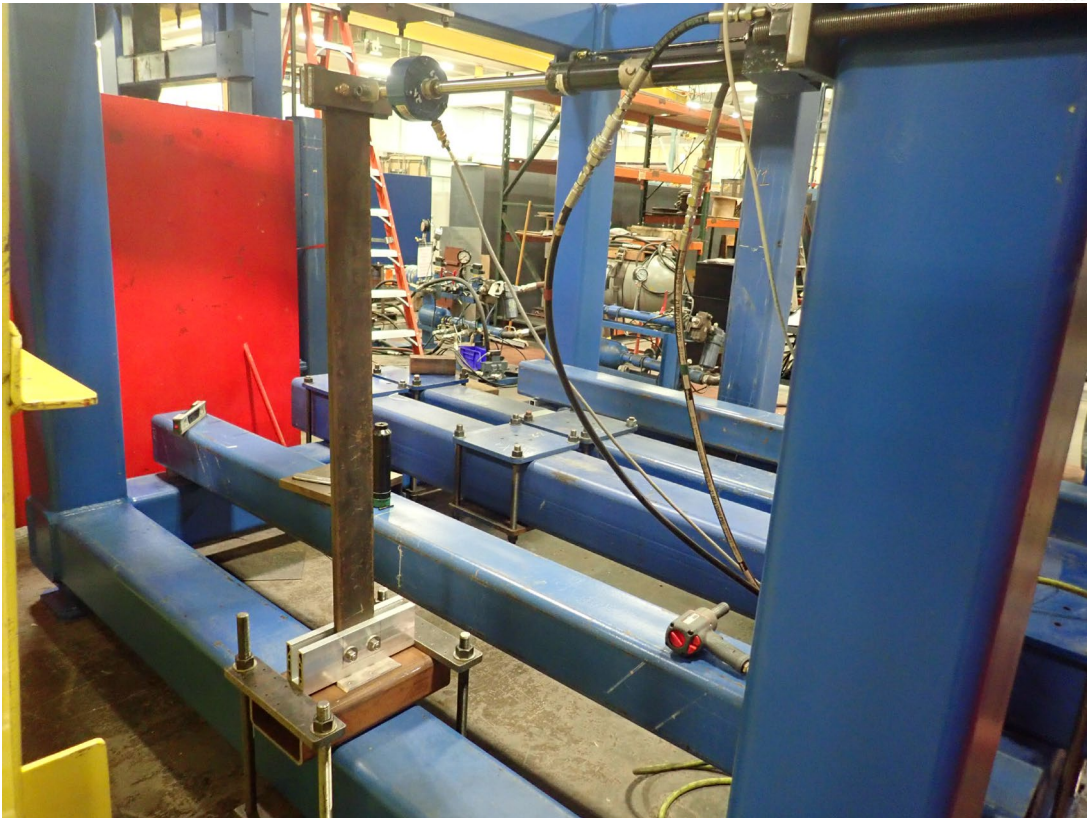
Photo 1 – File No. PA300968
Test Setup with Aluminum Shoe

The Anchoring Brackets were originally delivered with “aluminum shoes” to secure the steel panel to the UUT. During the first proof load test of Serial No. NB1C-S-1, it was found that the aluminum shoe was failing prematurely at approximately 164.3 lbf due to the aluminum material deforming around the bolt that secures the shoe to the Anchoring Bracket. As the aluminum shoe was not part of the UUTs, the shoes were removed from each Anchoring Bracket and replaced with the steel 90° angle. Serial No. NB1C-S-1 showed no evidence of damage or deformation and was subjected to a second proof load test utilizing the steel 90° angle.

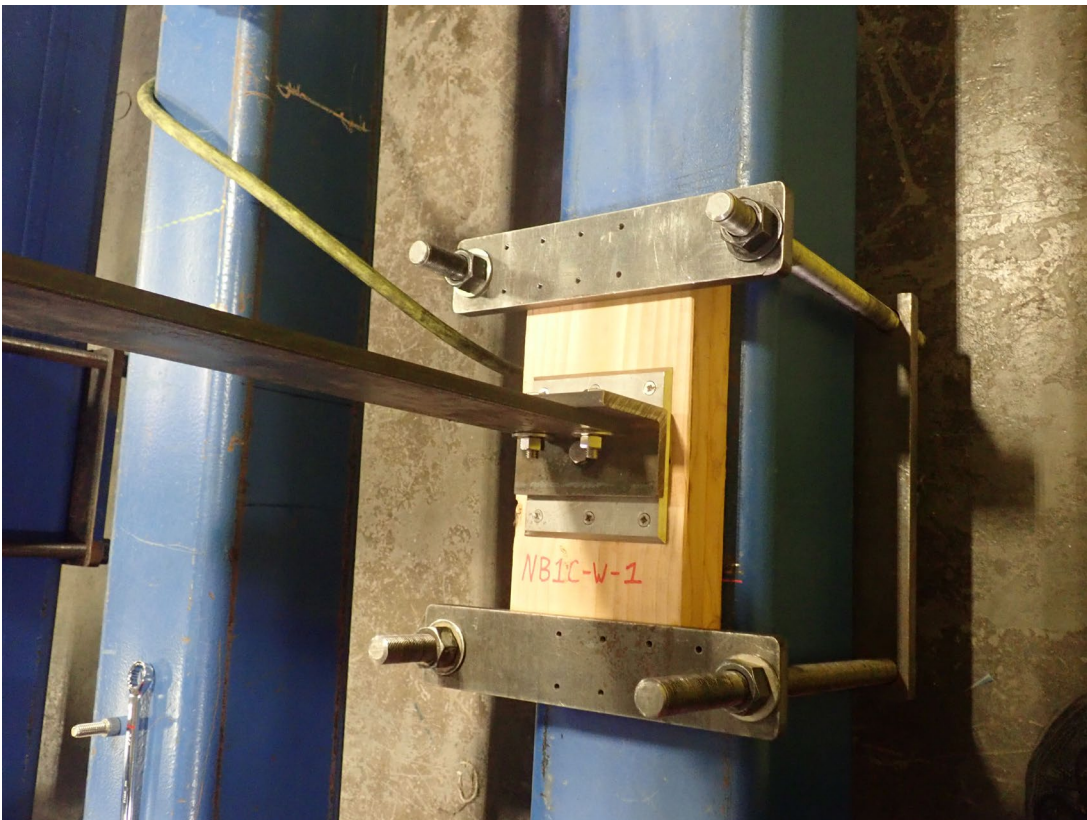
Photo 2 – File No. PA300986
Typical Test Setup with Steel 90° Angle

Ultimate load testing was performed by applying the largest lateral load possible, at a distance of 48 inches from the top surface of each Anchoring Bracket. For both tests, the load was applied through a 1/2-inch steel panel. The panel was secured to the Unit Under Test (UUT) utilizing a piece of steel 90° angle.

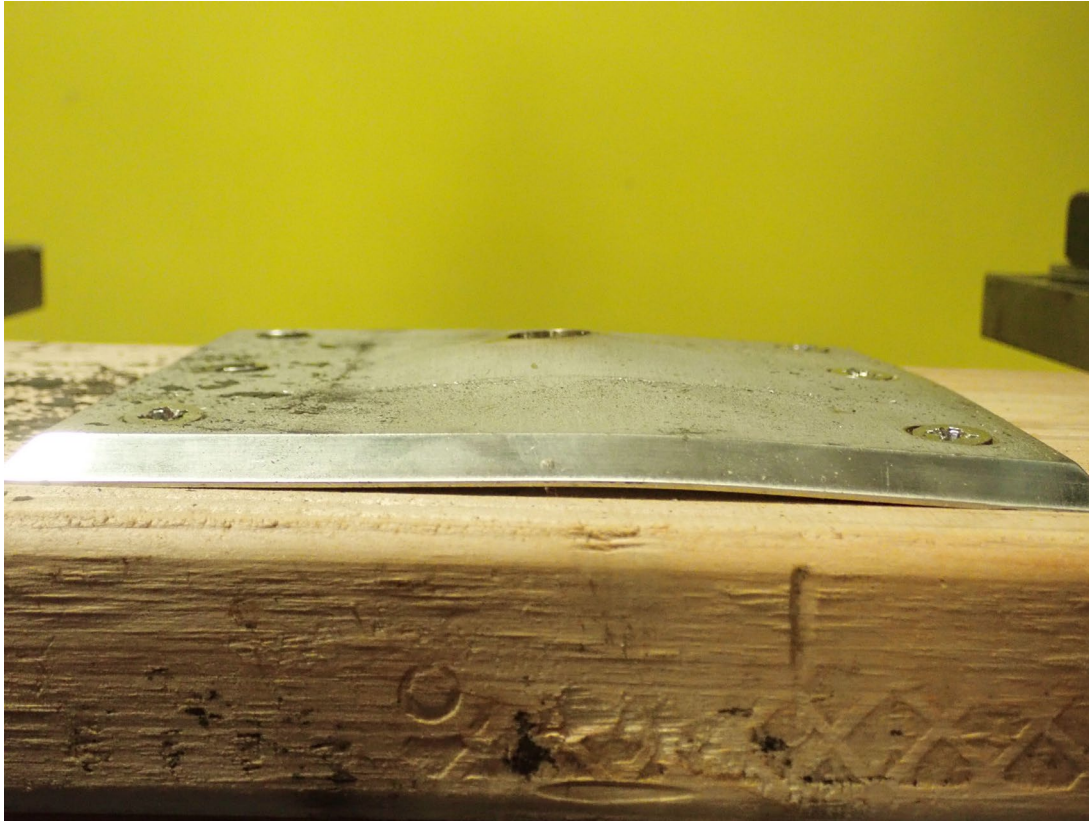
Photo 3 – File No. PA300990
Serial No. NB1C-W-3 Ultimate Test Deformation

Note 1: For Serial Nos. NB1C-S-3 and NB1C-W-3, there was concave shape deformation at the center of the Anchoring Bracket while the anchoring screws remained secured. It was also noted that the stainless steel bolt that secured the steel 90° angle to the Anchoring Bracket was bent in the applied load direction.

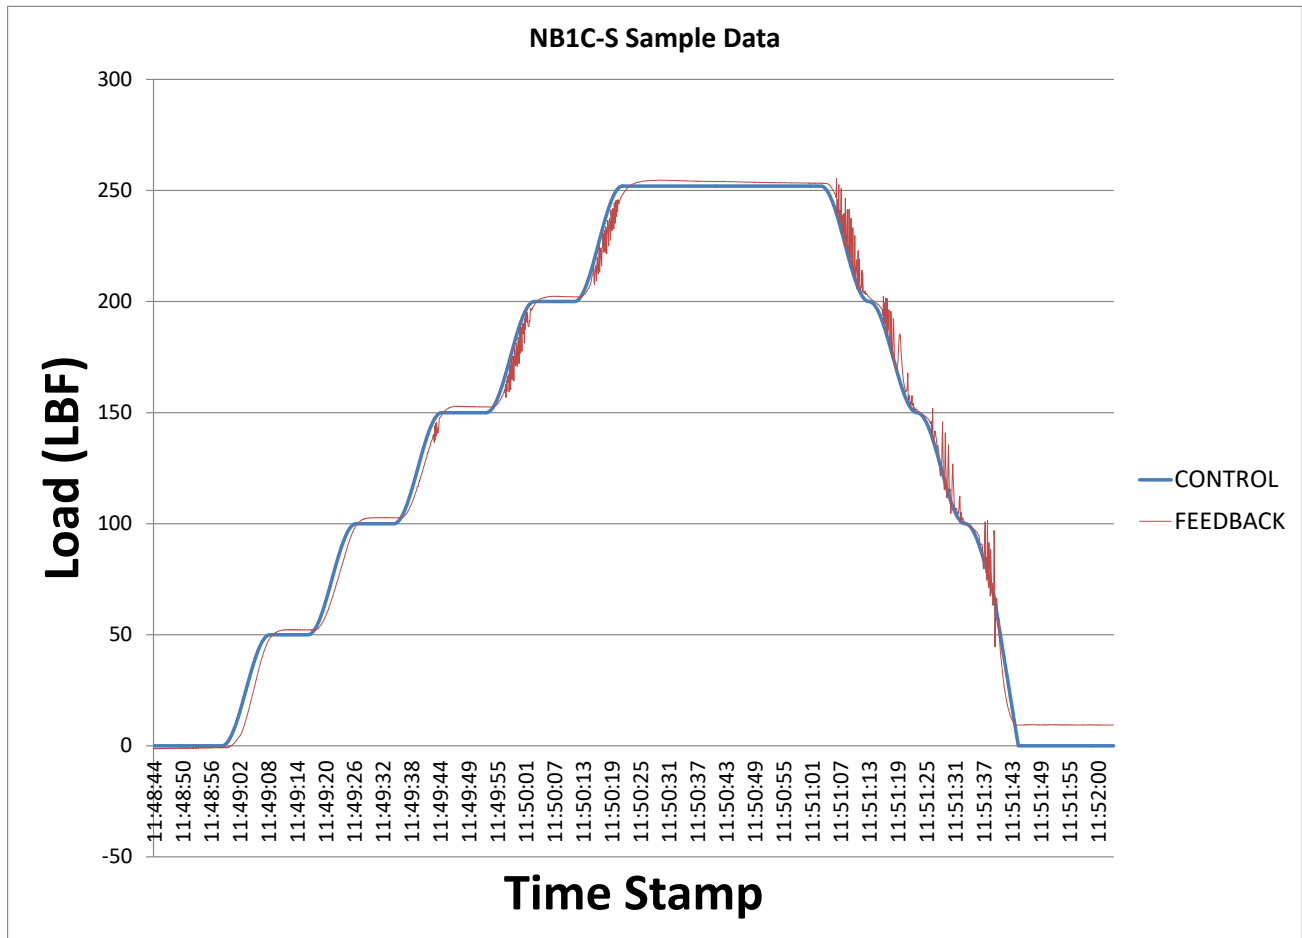
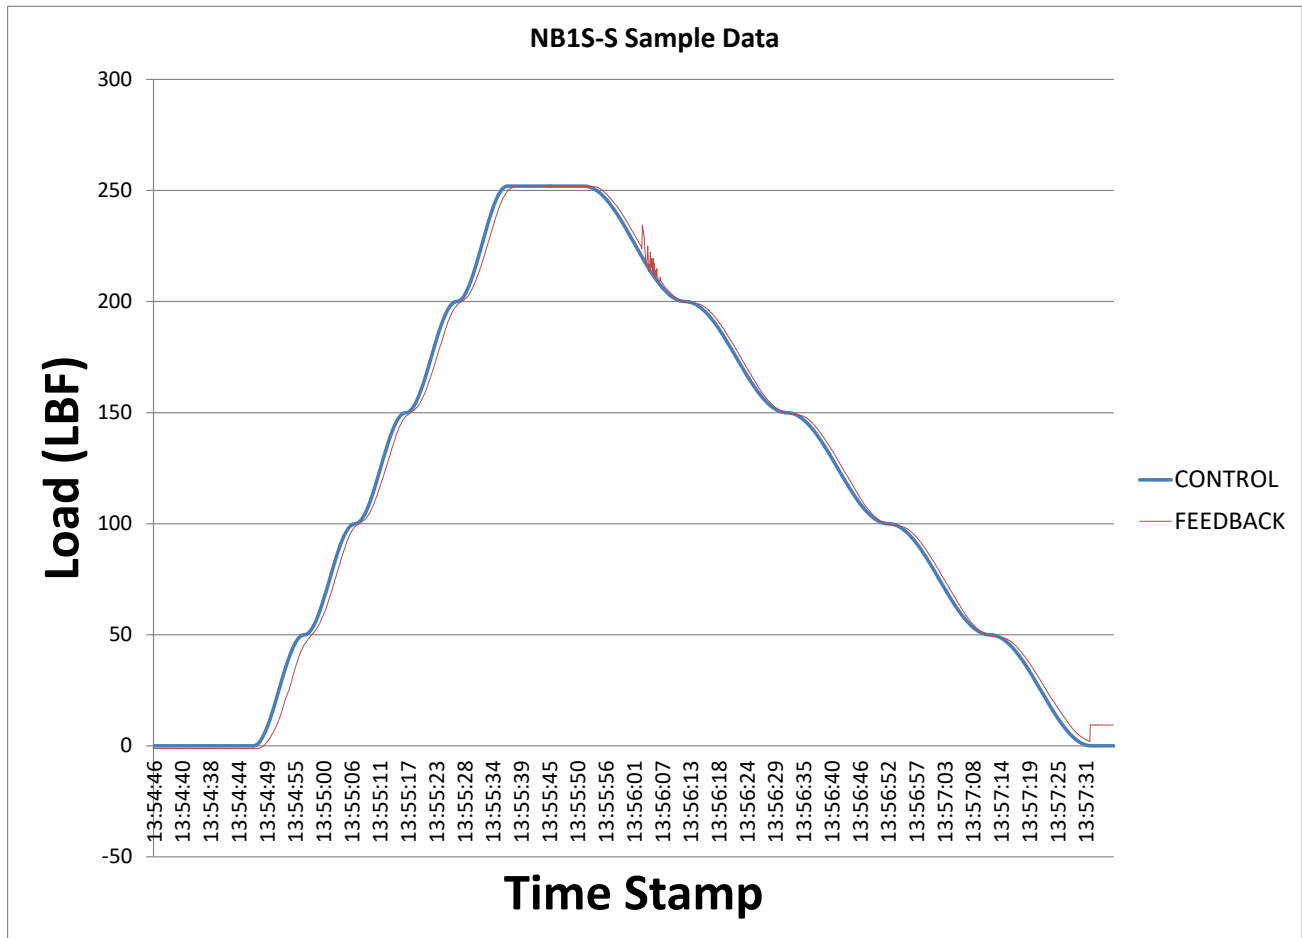
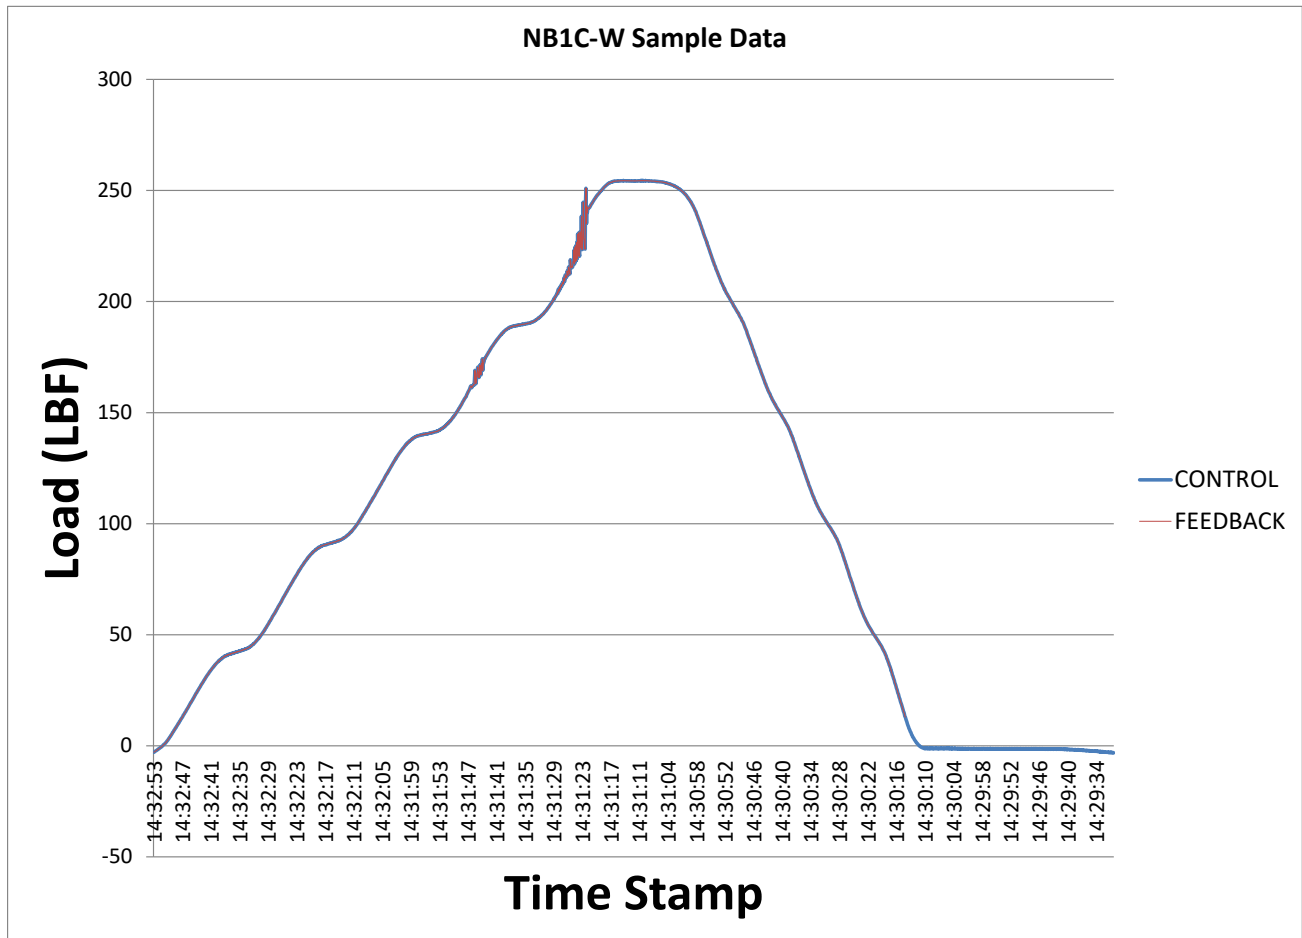
Representative Proof Load Graphs

Testing was performed on 30 October 2020 under reference (a) to the requirements of references (b) and (c). Proof load testing was performed by applying a 250-lbf lateral load, at a distance of 48 inches from the top surface of each Anchoring Bracket tested. The load was applied in 20% increments up to at least 250 lbf as shown in graphs of Enclosure 3. Once the 250-lbf load was reached, the load was then decreased in 20% increments. A visual inspection was performed after each test which checked for any damage or deformation of the Anchoring Brackets. None of the Anchoring Brackets showed evidence of damage, deformation, or failure of attachment after being subjected to the proof load test, as summarized in the table below.
